Manhole Inspection Summary

Manhole # S53KK_007MH

Insp Date: **3/20/08 11:15 AM**

Location Address: **Edison Highway**

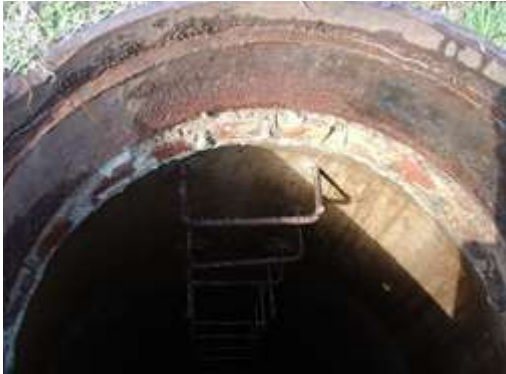
Defect 1

Infiltration: ☐ None ☒ **Joint** ☐ Cracks ☐ Mortar ☐ Roots ☐ Wall

Adjustment Joint

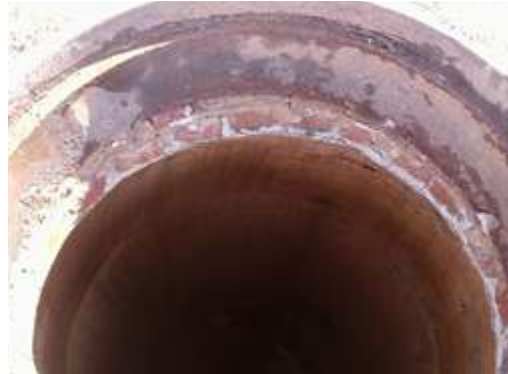
Defect 2

☒ **Leaks**

Frame Leaks

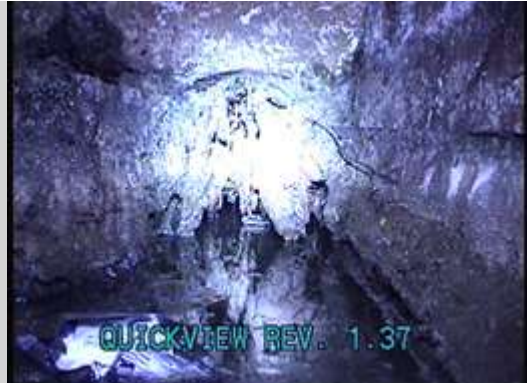
12 O'Clock Outflow

8 in. Circular Gravity Sewer
Pipe Out @ 12 O'Clock

Pipe Height: **8.4** (in.) Rod and Bar (Angled)
Pipe Material: **Clay** ☐ Pipe Lined
Invert Depth: **21.50** (ft.) Flow Characteristics: **Slow**
Deposits: ☒ None ☐ Mud ☐ Sludge ☐ Debris ☐ Grease
Silt Depth: (in.) Deposits Extent:
Infiltration: **None** Pipe Seal Cond: **Sound**

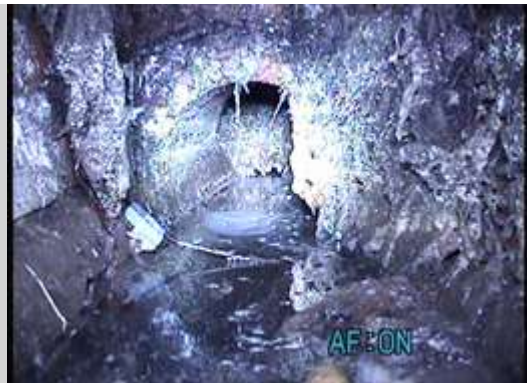
6 O'Clock Inflow

8 in. Circular Gravity Sewer
Pipe In @ 6 O'Clock

Pipe Height: **8.4** (in.) Rod and Bar (Angled)
Pipe Material: **Clay** ☐ Pipe Lined
Invert Depth: **21.30** (ft.) Flow Characteristics: **Slow**
Deposits: ☒ None ☐ Mud ☐ Sludge ☐ Debris ☐ Grease
Silt Depth: (in.) Deposits Extent:
Infiltration: **None** Pipe Seal Cond: **Sound**

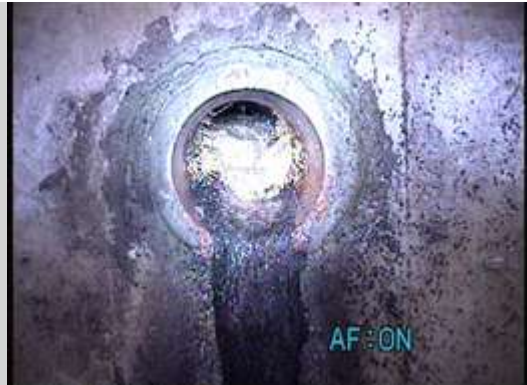
9 O'Clock Inflow

Pipe In @ 9 O'Clock

Pipe Height: **8.4** (in.) Rod and Bar (Angled)

Infiltration: **None**

Pipe Seal Cond: **Sound**

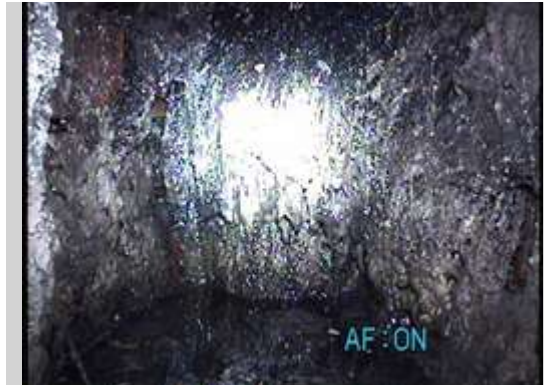
Drop In @ 9 O'Clock

Drop: **Outside** Rod and Bar

Angled: **Yes** Reading: **20.40** (ft.)

Inv Depth: **21.40** (ft.)

Drop Condition: **Open**
